# DEVELOPMENT OF MANUFACTURING METHODS AND PROCESSES FOR FLUXLESS BRAZING TO ALUMINUM THIN WALL TUBING AND FOIL

G. Martin  
AVCO Corporation

TECHNICAL REPORT AFML-TR-67-205

July 1967

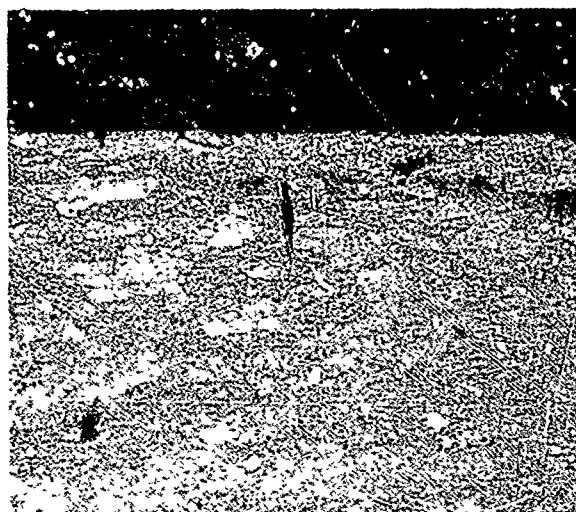
Mount #345

- b) Marker locating point 0.1 inch in toward blind hole from edge. (100X)

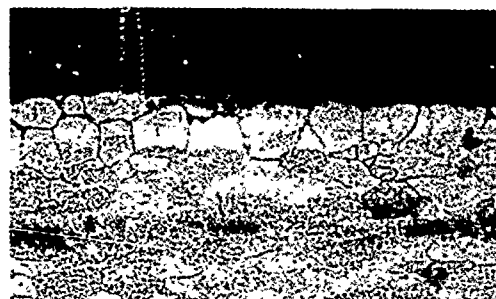
### 6951-4045 System--Microstructure

Mount # - - - - - 436  
 Distance from button center - 0.4 in  
 Specimen condition - brazed - T6  
 Etchant - Boric Acid + HF - (1 Min)  
 Magnification - - - - - 100X

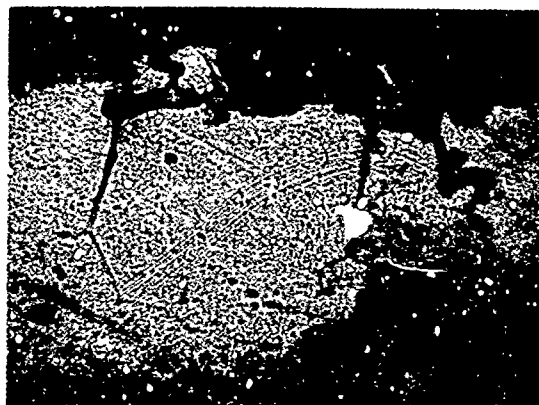
Figure 4-17

Photomicrographs of Corrosion Mode. 7005-4045 System

Mount # - - - - - 437  
 Environment - - Salt Fog  
 Etchant - Boric Acid + HF - - (1 Min)  
 Magnification - - - - - 250X

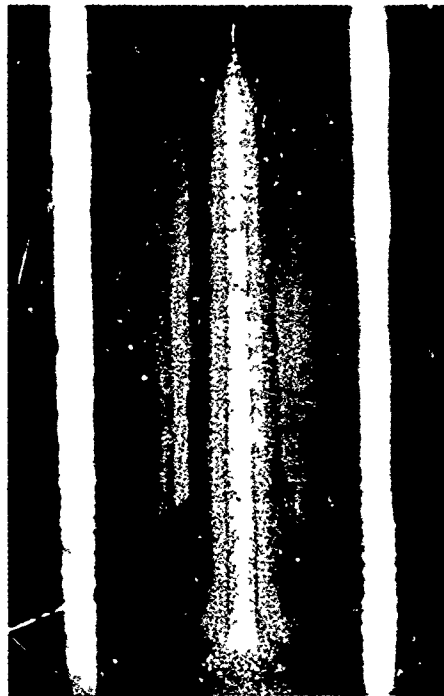
Macrograph of 30° included angle capillary column of 718 braze filler metal. Magnification-1.75X

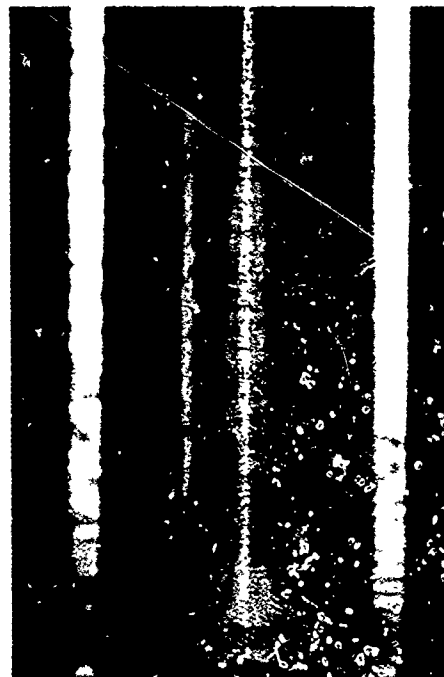
Macrograph of 30° included angle capillary column of 4045 braze filler metal. Magnification-1.75X

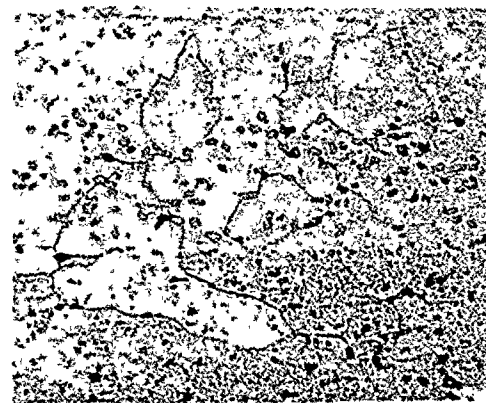
Bonding Cycle (24 PSI-60 Min.)  
Keller Etched - 250X - Mount #458

7005-4045 Bonded Joint System

Idiomorphic crystals were mainly retained inter- and intragranularly rather than at the component interface of the 4045 material. This is illustrated in Figures 5-4 through 5-4d.

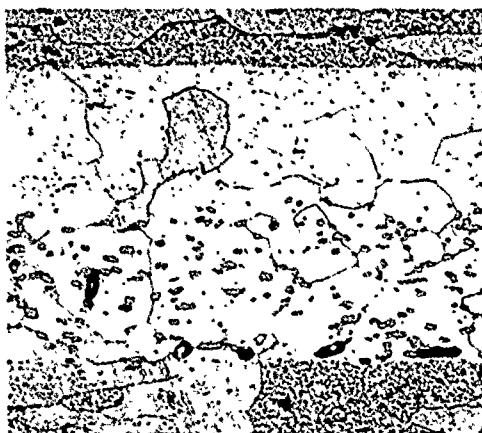
Figure 5-4a

Boric Acid HF Etched - 250X  
Mount #464 - Bonding Cycle  
34 PSI - 60 Mins.

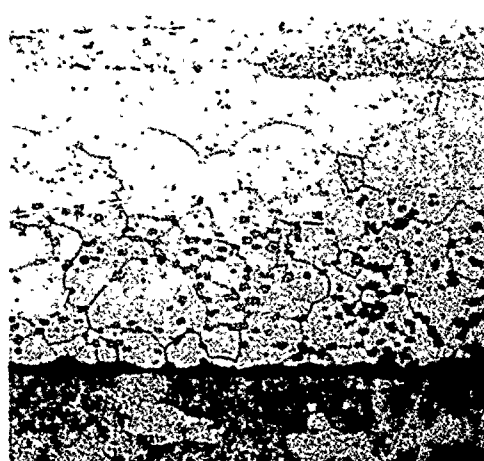
Figure 5-4d

Boric Acid HF Etched - 250X  
Mount #503 - Bonding Cycle  
54 PSI - 30 Mins.

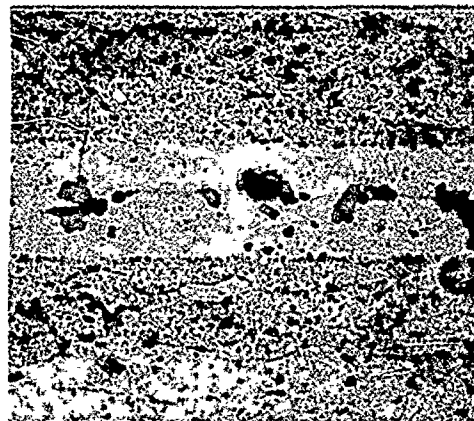
Keller Etched - Mount #458 - 250X  
Bonding Cycle - 24 PSI - 60 Mins.

7005 - 718 Bonded Joint System

The heavy concentrations of idiomorphic ( $\alpha$ -constituent) crystals located at grain boundaries generally through the center of the intermediate material show some pseudo coring effect, this is best illustrated in Figure 5-5c. This condition was overcome by reducing the bonding cycle to 30 minutes.

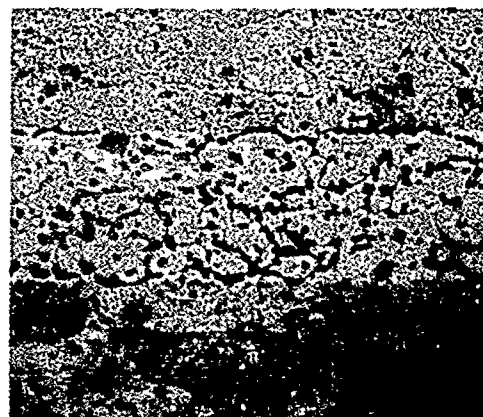
Figure 5-5d

Boric Acid HF Etched - Mount #503  
250 X - Bonding Cycle - 54 PSI -  
30 Mins.

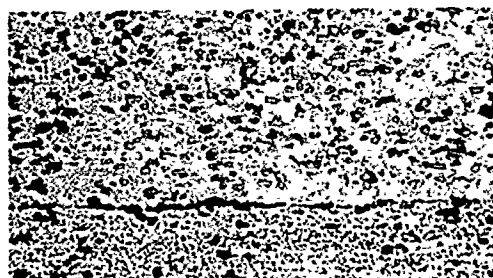
Figure 5-8

Typical microstructure of 3003 and 4045 system bonded at 54 PSI and 30 minute time cycle.

Typical microstructure of 3003 and 4045 system bonded at 54 PSI and 75 minute time cycle.

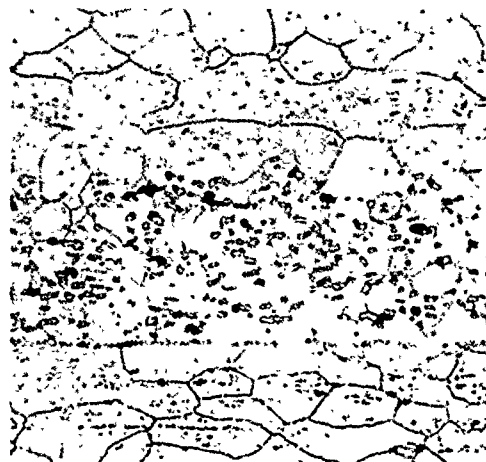
Mount #559  
Magnification - 250X  
Soak Time - 10 Minutes

Mount #563  
Magnification - 250X  
Soak Time - 25 Hours

Microstructures of 6951-4045 System Showing Short Time Through  
100 Hours at 300 F Environment Effect

Figures 5-15 through 5-17 inclusive, illustrate the progressive affect of heat and time on the microstructure.

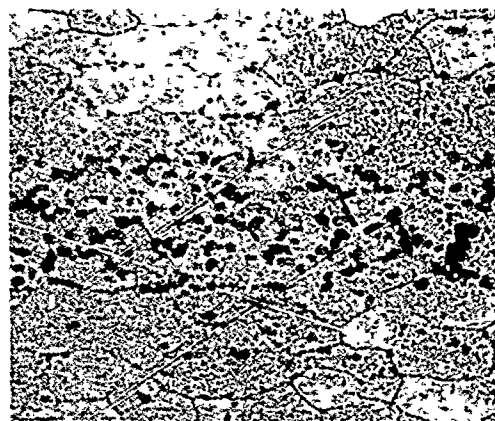
Mount #565  
Magnification - 250X  
Soak Time - 25 Hours

Mount #572  
Magnification - 250X  
Soak Time - 50 Hours

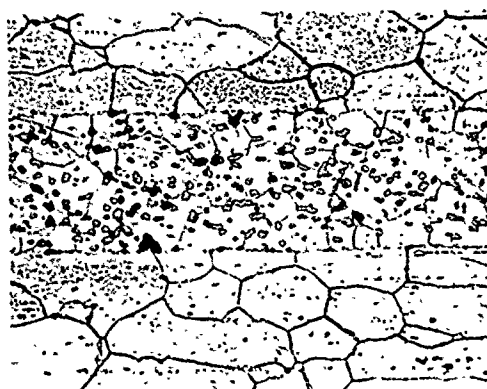
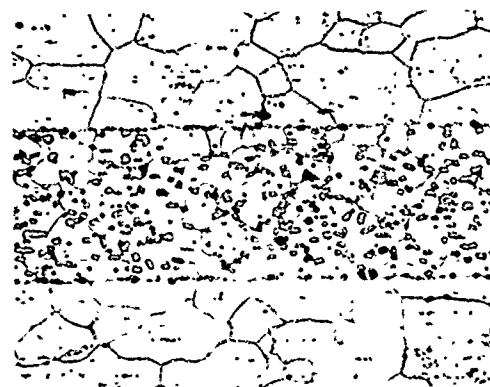
Mount #559 - Mag 250X  
300 F - 10 Minutes  
Boric Acid HF Etched

Mount #573 - Mag 250X  
500 F - 25 Hours  
Boric Acid HF Etched

Mount #565 - Mag 250X  
500 F - 50 Hours  
Boric Acid HF Etched

No pronounced microstructure changes were observed on the 6951-718 diffusion bonded joints having been subjected to 300 F and 350 F thermal environments of 10 minutes, 25 hours, 50 hours, and 100 hours. However, the 500 F thermal environment soaking showed considerable fine matrix solid solution precipitates throughout both interleaf and parent metal alloy after 25 hours. This mechanism increased through the 50 hour and 100 hour environments. No apparent interleaf constituent coalescence was evident. Figure 5-18 illustrates the precipitation mode discussed in the above.

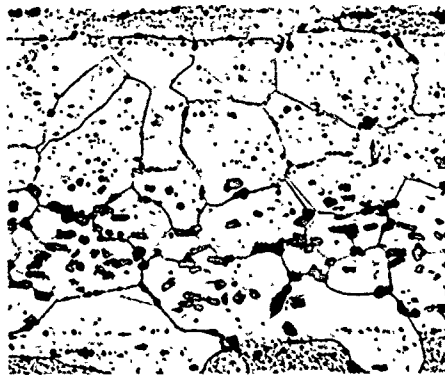
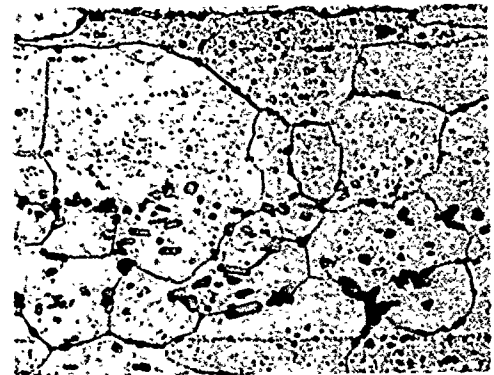
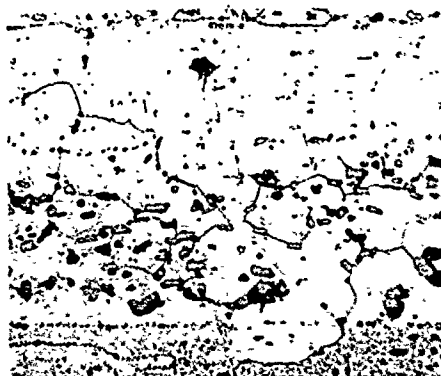
Mount #559 - Mag 250X  
300 F - 10 Minutes  
Boric Acid HF Etched

Mount #565 - Mag 250X  
500 F - 25 Hours  
Boric Acid HF Etched

Mount #572 - Mag 250X  
500 F - 50 Hours  
Boric Acid HF Etched

Mount #577 - Mag 250X  
500 F - 100 Hours  
Boric Acid HF Etched

Microstructure of 7005-4045 System Showing Effect of 300 F-10 Minutes,  
500 F-25 Hours, 500 F-50 Hours, 500 F-100 Hours Thermal Environment

No microscopic changes were observed as a result of subjecting the bond joint specimen to 300 F and 350 F thermal environment. The bonded joint specimen subjected to 25 hours, 50 hours, and 100 hours at 500 F, however, showed fine matrix solid solution precipitates throughout the interleaf alloy (4045) matrix. The interleaf alloy grain boundaries showed progressive depletion of material as a function of time, and an increase in coalescence of major precipitates. Figure 5-19 illustrates the joint microstructure with no thermal environment effects vs joints subjected to 500 F for 25 hours, 50 hours, and 100 hours.

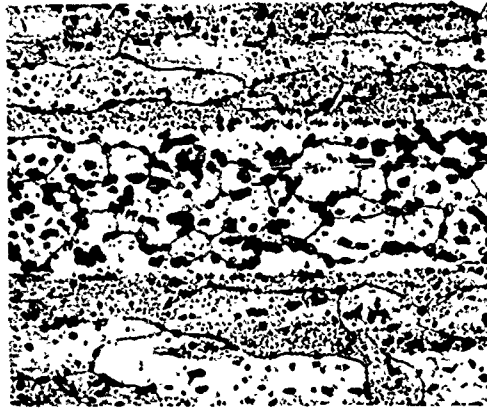
Mount #559 - Mag 250X  
300 F - 10 Minutes  
Boric Acid HF Etched

Mount #565 - Mag 250X  
500 F - 25 Hours  
Boric Acid HF Etched

Observation of the 7005-718 bonded joint system followed the same trend as did the preceding 7005-4045 system.

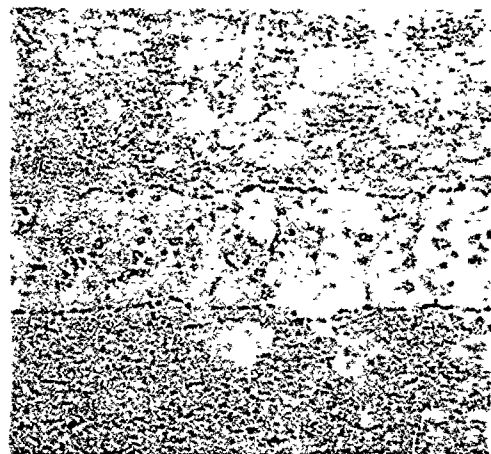
Figure 5-21

Mount #670  
Magnification-250X  
Soak Time - 50 Hours

Mount #672  
Magnification-250X  
Soak Time - 100 Hours

Microstructure of 6061-4045 System Showing Effect of Short Time Through 100 Hours at 300 F Environment.

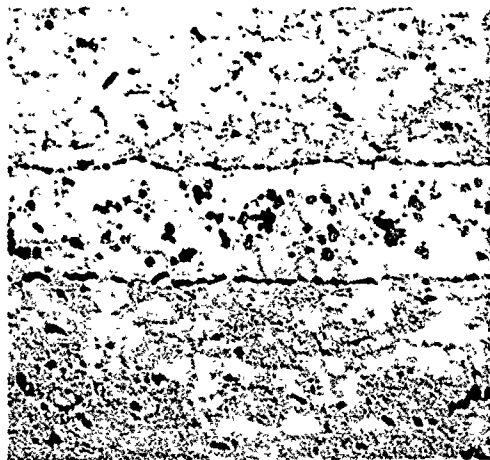
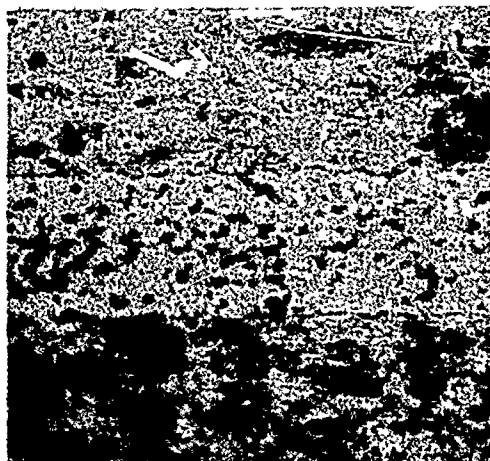
Figure 5-21

Mount #668  
Magnification-250X  
Soak Time - 10 Minutes

Mount #669  
Magnification-250X  
Soak Time - 50 Hours

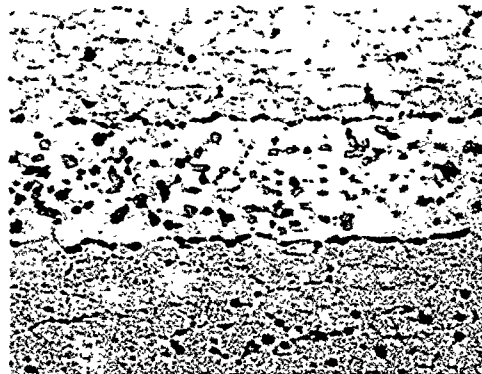
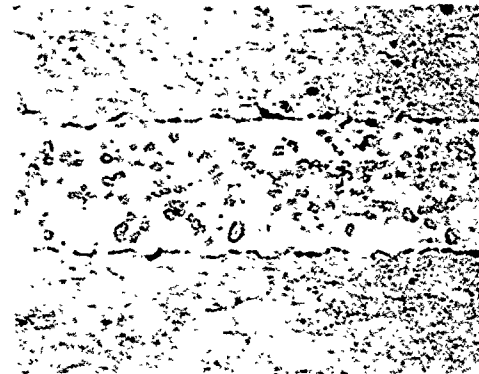
Figure 5-22

Mount #670  
Magnification - 250X  
Soak Time - 50 Hours

Mount #670  
Magnification - 250X  
Soak Time - 100 Hours

Microstructure of 6061-718 System Showing Effect of Short Time Through 100 Hours at 300 F Environment

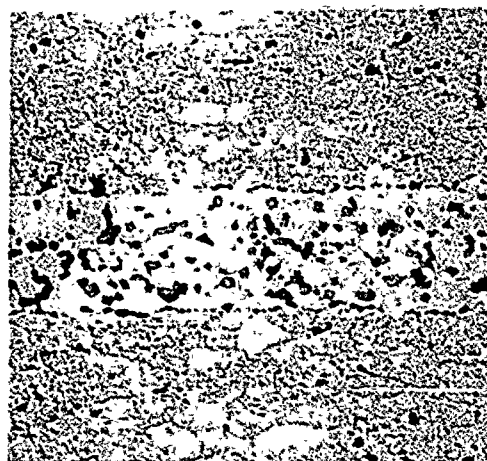
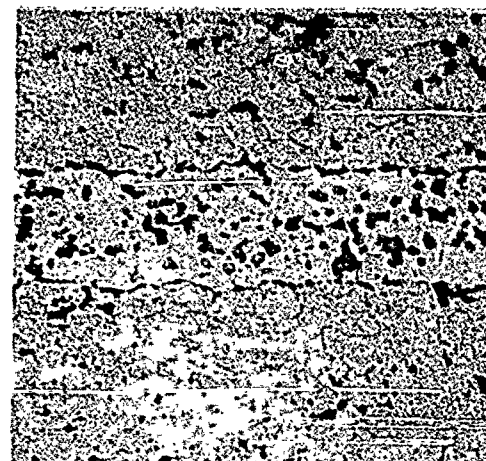
Figure 5-22

Mount #668  
Magnification - 250X  
Soak Time - 10 Minutes

Mount #668  
Magnification - 250X  
Soak Time - 25 Hours

Mount #669  
Magnification - 250X  
Soak Time - 100 Hours

Microstructure of 6061-718 System Showing Effect of Short Time  
Through 100 Hours at 500 F Environment

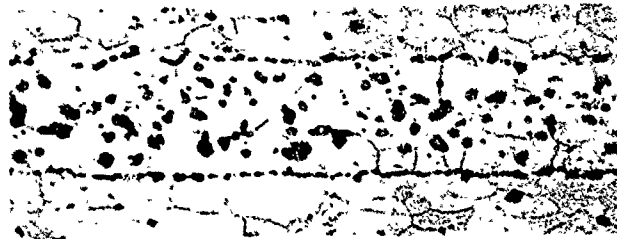
#### Contaminated Interface Microstructure

Mount #619 - Mag 250X  
Boric Acid HF Etched  
Shear Value-17,946 PSI  
Excessive Interface  
Bounding Buffer Effect  
Minor Transcrystalline  
Growth Only

6061-4045 System - Over Spray Scrubbing Omitted

New specimen, Batch #3, were prepared with a final two (2) minute water rinse scrubbing included in the metal preparation. Random tests confirmed the preceding conclusion since average shear values increased to 22,421 PSI for the 6061-4045<sup>(1)</sup> system, and 26,030 PSI<sup>(1)</sup> for the 6061-718 system. The microstructure of interfaces was improved. Figure 5-25 illustrates the typical interface differences.

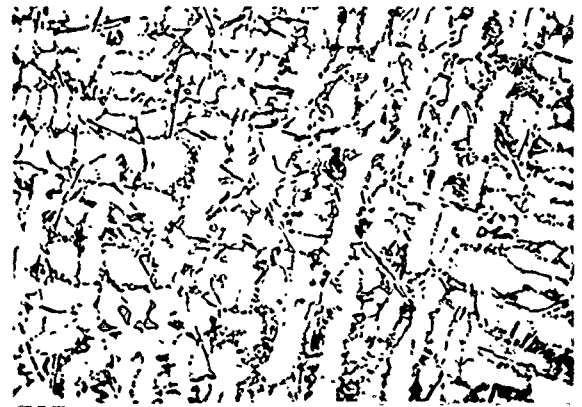
Section 5. Magnification 200X  
Boric Acid-HF Etched  
Heat Treated 10 Hours at 950 F

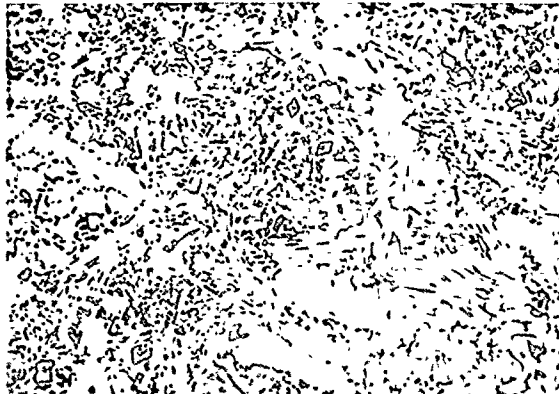
Section 2. Magnification 200X  
Boric Acid-HF Etched  
Heat Treated 10 Hours at 950 F

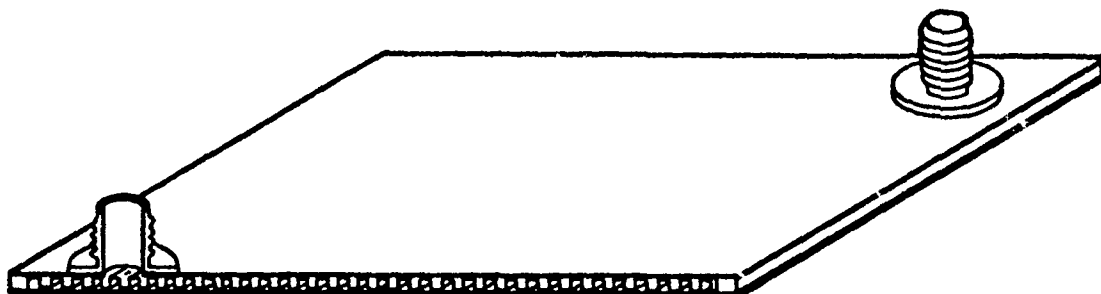
## THERMAL CONDITIONING AND MOUNTING PANEL

- 1) Fluxless brazed
- 2) Turbulent extended surface fin. Pitch 5 to 7 per inch.  
Height 0.090" approx.
- 3) Face sheets 0.008"
- 4) Fittings for proof pressure leak testing.

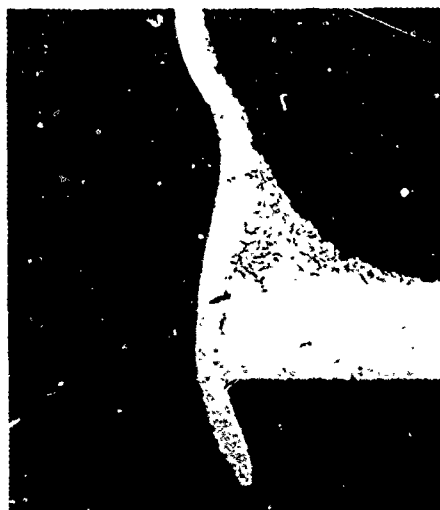
Figure 7-6

#### Microstructure of Type "A" Brazed 6061 Al Tube Joints

Mount # - 392  
Tube Alloy - 6061  
Plate Alloy - 6951  
Filler Metal - 4045  
Braze Temp. - 1075°F  
Braze Time - 3.5 Mins.  
Filler Thickness - .001 In.  
Joint Type - A  
Magnification - 30

Comments: Tube wall filler diffusion was controlled.

Typical photomicrographs of each brazed joint test series are presented in Figures 7-6 through 7-14 inclusive.

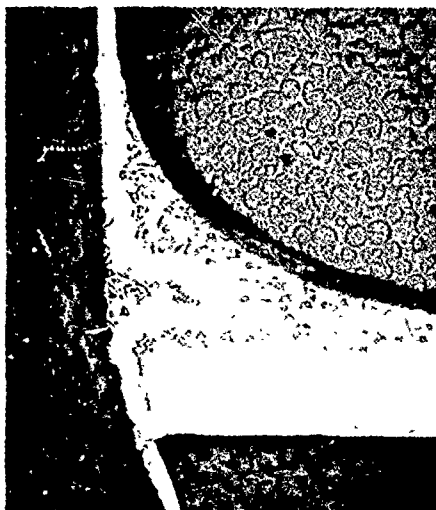
Figure 7-8

# Microstructure of Type "A" Brazed 6061 Al Tube Joints (cont'd)

Mount # - 365  
 Tube Alloy - 6061  
 Plate Alloy - 6951  
 Filler Metal - 4045  
 Braze Temp. - 1077°F  
 Braze Time - 3.5 Mins.  
 Filler Thickness - .003 Inches  
 Joint Type - A  
 Magnification - 30

Comments: Severe metal diffusion of tube material is evident at root of fillet.

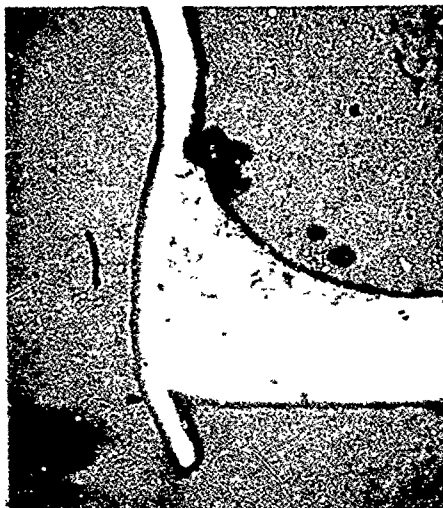
Figure 7-9

# Microstructure of Type "A" Brazed 3003 Al Tube Joints

Mount # - 359  
 Tube Alloy - 3003  
 Plate Alloy - 6951  
 Filler Metal - 4045  
 Braze Temp. - 1077°F  
 Braze Time - 3.5 Mins.  
 Filler Thickness - .002 Inches  
 Joint Type - A  
 Magnification - 30

Comments: Well controlled tube wall diffusion.

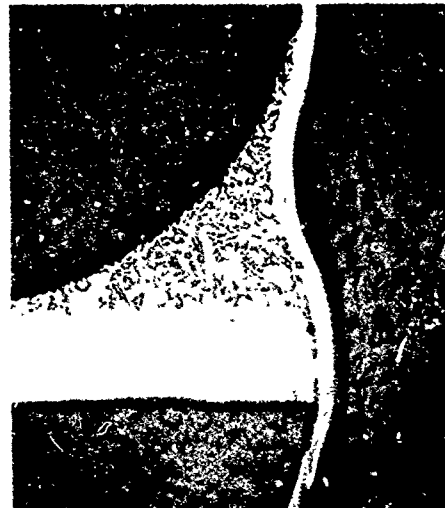
Mount # - 361  
 Tube Alloy - 3003  
 Plate Alloy - 6951  
 Filler Metal - 4045  
 Braze Temp. - 1077°F  
 Braze Time - 3.5 Mins.  
 Filler Thickness - .003 Inches  
 Joint Type - A  
 Magnification - 30

Comments: Well controlled tube wall diffusion.

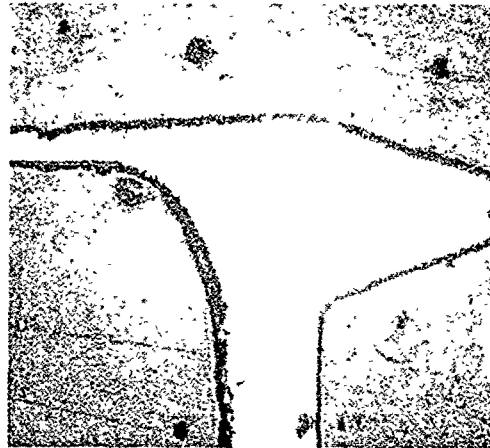
# Microstructures of Type "B" Brazed 6061 Al Tube Joints

Mount # - 366  
 Tube Alloy - 6061  
 Plate Alloy - 6951  
 Filler Metal - 4045  
 Braze Temp. - 1077°F  
 Braze Time - 3.5 Mins.  
 Filler Thickness - .003 Inc.  
 Type Joint - B  
 Magnification - 30

Comments: Excessive diffusion at fillet foot thin tube wall.

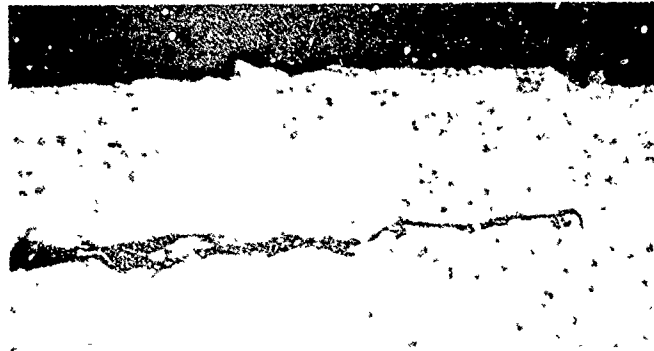
Figure 7-28

Axial Flow Tube To Header Plate Joint Defect

Mount # - 510  
Magnification - 200X  
Boric Acid HF Etched

Microscopic studies of defective areas showed that the brazed joint leaks were due to localized porosity in the braze filler metal. Figure 7- 28 illustrates a defective joint which was sectioned normal to the tube axis.

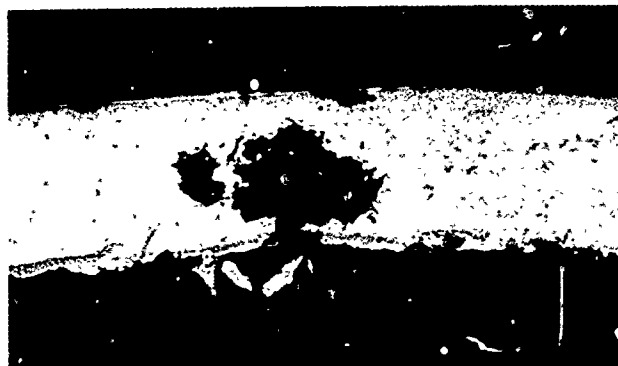
Figure 7-31

#### Tube Wall Defect

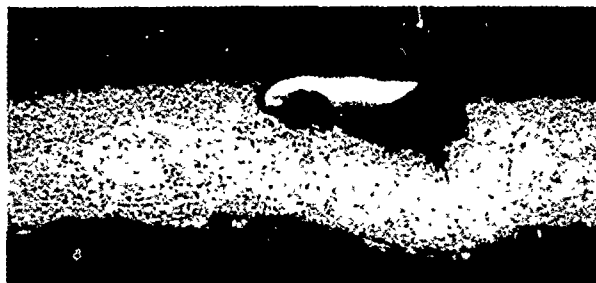
Figure 7-33

Tube Cross Section-Illustrates Inclusion at End of Defect

The defects occurring in the 1/8" OD thin wall tubes were identified as being in the as-received material occurring as porosity and inclusions. Random lengths of the as-received tubing were inspected under a stereomicroscope; this inspection revealed numerous surface defects. The majority of these defects showed up as surface porosity. Selected defective areas were sectioned and progressively polished through the defect; this investigation revealed gross voids under the porous surface which continued through to the inner wall surface. A number of surface imbedded inclusions were detected in which traces of copper were found. Figure 7-32 illustrates a surface inclusion. The cross sections of this area are shown in Figure 7-33. Figure 7-34 shows a large surface void with an inclusion at one end. The wall is deformed inward which suggests that the inclusion was forced into the tube wall after the extrusion operation.

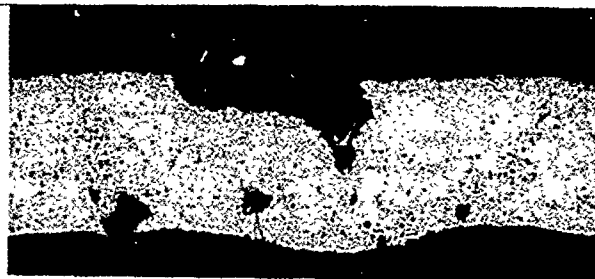
Figure 7-34

Tube Cross Section-Illustrates Opposite End to Figure 7-33

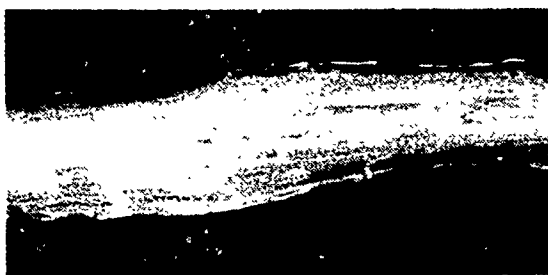
Tube Surface Contamination- As Received

Magnification  $2\frac{1}{2}X$   
Etchant None  
Figure Number 7-35

Hydraulic grade 1/8 inch O.D. 6061 tubing was procured having been hydrostatically tested at 300 psig by the vendor. Visual and microscopic examination of the tubing as received revealed no apparent inclusions. A few light longitudinal marks were detected visually, but had no apparent depth when cross sectioned and examined microscopically. A residue of an undetermined nature was observed on the inside surface of the tubing (Figure 7-35) which when subjected to normal cleaning and a simulated braze and heat treat cycle became a black tenacious coating (Figure 7-36). Precleaning in concentrated nitric acid at 200 F for 2 minutes removed all visual signs of contamination when followed by normal cleaning and a simulated braze and heat treatment cycle (Figure 7-37).

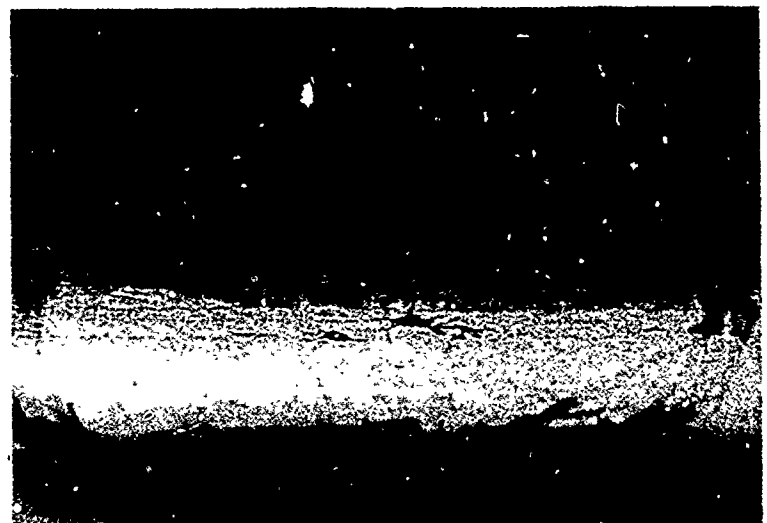
Close up view of leak location shown above. Note typical corrosion pattern.

# Section of Defective Tube Wall Removed For Brazement
